# Manhole Inspection Summary

Manhole # S43QQ\_016MH

Insp Date: **4/2/07 1:35 PM**

**Location** Address: **2504 HARFORD RD**

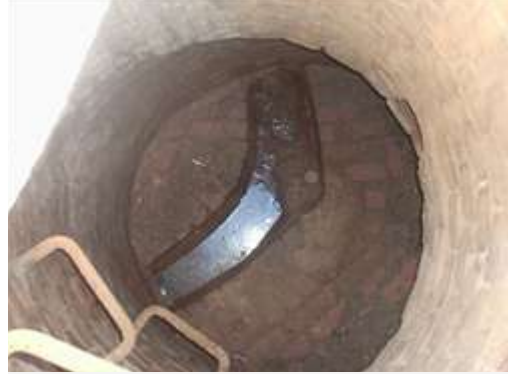
Top View

**Steps** Count: **3** Missing: **0** ☒ **Corroded**

**Surcharge** ☒ **Evidence Of Surcharge** Depth: **1** (ft.) ☐ Active Surcharge Present

Corroded steps. Evidence of surcharge - Bench debris. Channel debris.

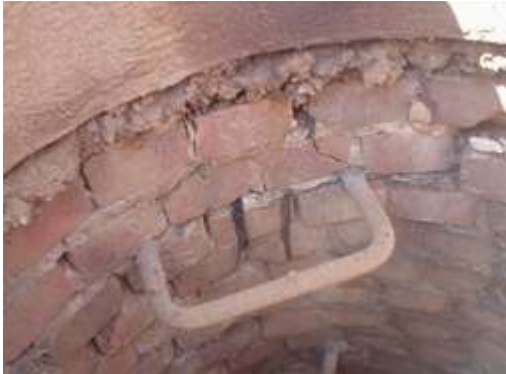
Defect

Condition: ☐ Sound ☒ **Cracked** ☐ Root Intrusion ☒ **Loose Brick** ☒ **Deteriorated**

Infiltration: ☐ None ☒ **Joint** ☐ Cracks ☐ Mortar ☐ Roots ☒ **Wall**

Corbel deterioration, cracks and infiltration.

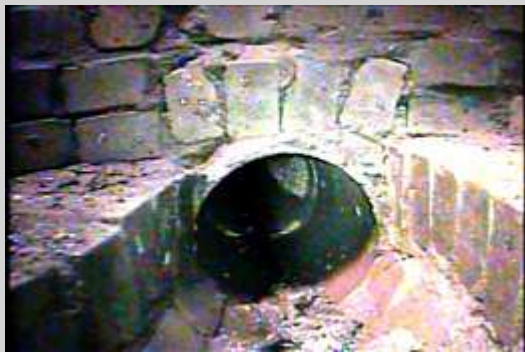
### 8 in. Circular Gravity Sewer Pipe Out @ 12 O'Clock

Barrel deterioration and infiltration. Channel deterioration.

Deposits: ☐ None ☒ **Mud** ☐ Sludge ☒ **Debris** ☐ Grease

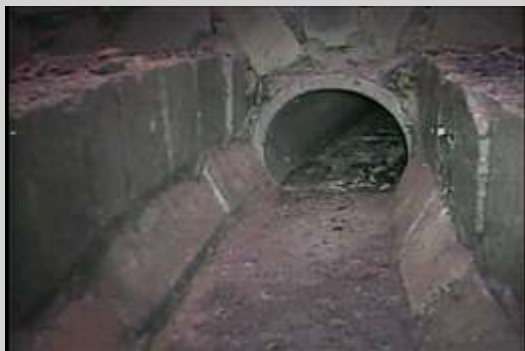
### 6 in. Circular Gravity Sewer Pipe In @ 8 O'Clock

Barrel infiltration and deterioration. Channel deterioration.

Deposits: ☐ None ☒ **Mud** ☐ Sludge ☒ **Debris** ☐ Grease
